NEWRY RIVER CURRENTS

December 30, 2008
Jeff Stern, editor

Town Completes Sunday River Outward Bound Project

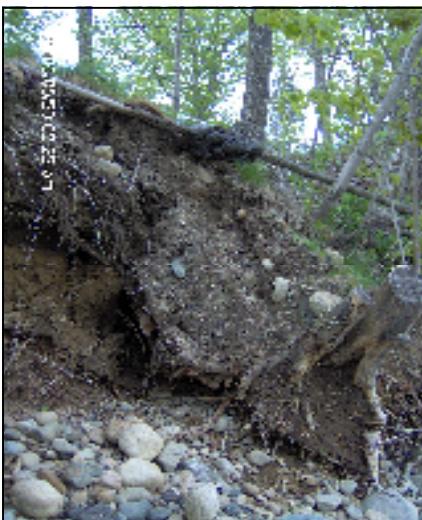
Bank erosion crept so close to the road a car roof is visible in upper center of this 2006 photo taken from the river 2 years before construction.

Prior to construction, only 15 feet of rapidly-eroding riverbank remained between the Sunday River and its namesake road. The Sunday River Road is the only way to access logging sites, the former Outward Bound school, homes, camps, and jeep and hiking trails in the Upper Sunday River Watershed.

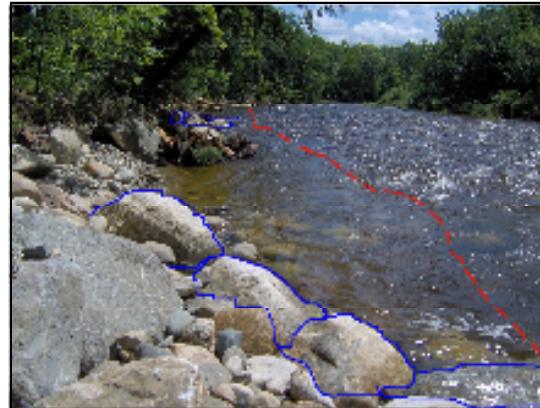
Rock vanes (blue outlines) deflect flows away from bank into middle of channel and create calm water at toe of bank (left of dashed red line) to protect the bank. View down river. A bar buddy is visible between the vanes.

Four hundred feet of eroding riverbank where the Sunday River Road meets the Outward Bound Road were treated by installation of a series of six rock vanes that jut out into the river facing upstream. The vanes deflect flows away from the vulnerable bank back toward the middle of the river.

An excavator moved huge 6-7 foot boulders into place. The vanes slope down into the water; a design that ensures their effectiveness at different water levels. They were keyed into the bank to prevent washout during flood events.

For added protection, five "bar buddies" were installed between the rock vanes. Hemlock trees were used. Each bar buddy consists of an anchor tree that was driven into the riverbed about 20-25 feet with the root mass poking above the water surface. Additional trees were attached to the anchor tree with high-strength cable and positioned horizontally along the toe of the slope.

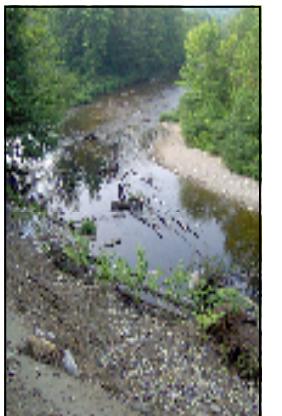
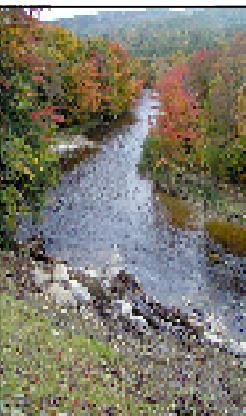
View upriver. Photo on left taken July 27, 2007 a year before construction. Photo on right taken Sept. 29, 2008 after installation of four rock vanes and two bar buddies. Logs were added to the existing jumble of trees on the shore. Winter rye that was planted on the upper, re-shaped bank is growing in. Seedling pine trees were planted on the bench below the winter rye. Three of the vanes are captured in the photo at right. Can you spot them?

The photos and box to the left describe what was done. Basically we used the same techniques as at Sunday River Outward Bound, though, of course, they were tailored to the unique features at this site.

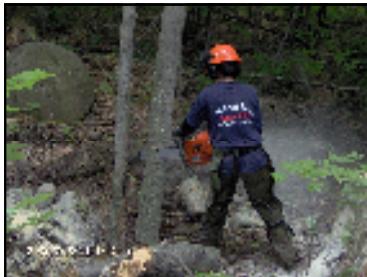
A sawyer cuts a tree for “chop and drop”.

The technique being studied involves adding large woody debris to streams. Dubbed “chop and drop” by project participants, sawyers cut trees of various species and about 10”-18” in diameter at strategic spots along a stream bank. The trees fall across the stream. Chop and drop can improve a damaged

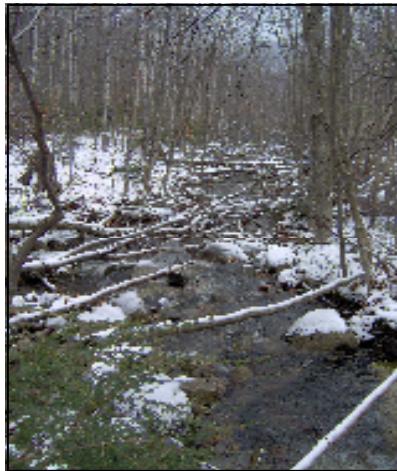
Stream in the Upper Sunday River Watershed treated with “chop and drop” in 2007. Trees will settle into the water in subsequent years.

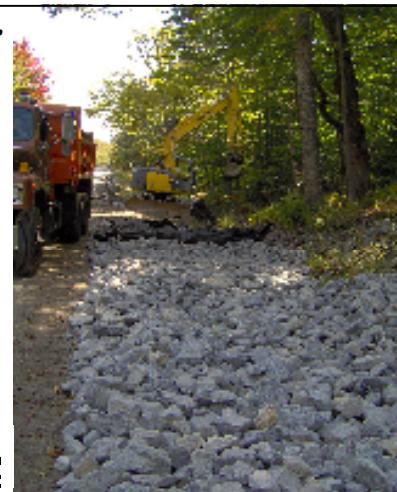
MDOT completed work in fall 2007. In this photo, an excavator lines a road ditch with large rock and digs a plunge pool to intercept storm runoff before it can carry eroding soil into a brook that feeds the Bear River.

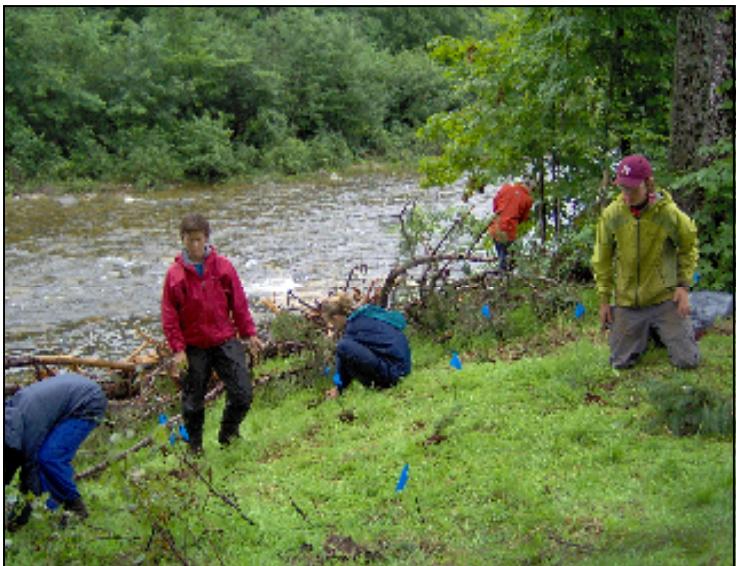
Bare areas created on the bank where equipment, boulders and trees were transported to the Sunday River were immediately seeded with fast-growing winter rye and mulched.

Two weeks after construction, students from the nearby Hurricane Island Outward Bound School planted seedling white pine and red pine trees amongst the green carpet of winter rye. (Blue flags mark planting locations for the trees.)

The extensive root systems the trees put down as they grow will further stabilize the once-eroding bank.
